Manhole Inspection Summary

Manhole # S13II2010MH

Location Address: **6106 EASTCLIFF DR**

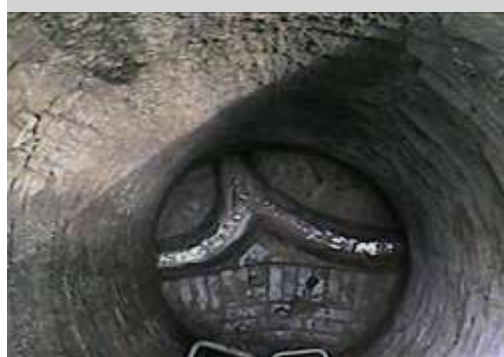
Top View

Barrel infiltration. Bench debris.

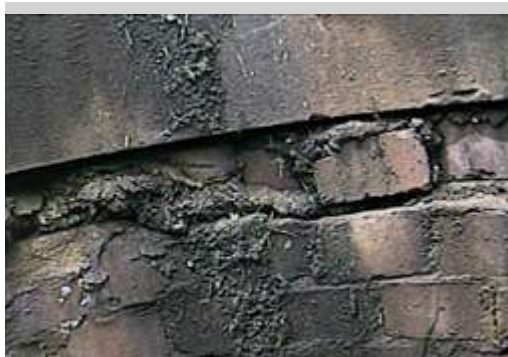
Defect

Condition: ☐ Sound ☐ Cracked ☒ **Leaks**

Condition: ☐ Sound ☐ Cracked ☐ Root Intrusion ☒ **Loose Brick** ☒ **Deteriorated**

Infiltration: ☐ None ☒ **Joint** ☐ Cracks ☒ **Mortar** ☐ Roots ☐ Wall

Frame leaks. Adjustment deterioration, loose brick, and infiltration.

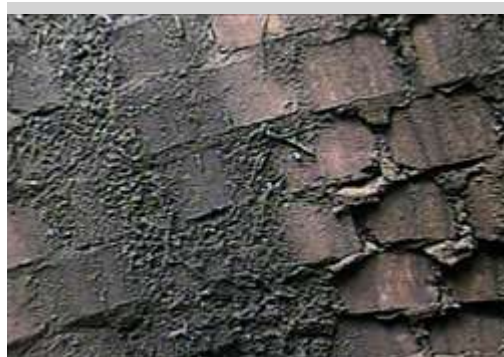
Defect

Infiltration: ☐ None ☐ Joint ☐ Cracks ☒ **Mortar** ☐ Roots ☒ **Wall**

Adjustment and Corbel infiltration.

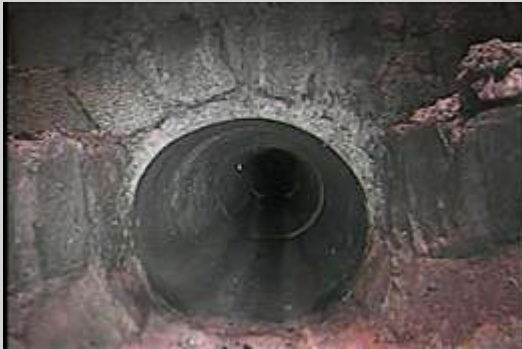
8 in. Circular Gravity Sewer Pipe Out @ 12 O'Clock

Deposits: ☐ None ☐ Mud ☐ Sludge ☐ Debris ☒ **Grease**

Silt Depth: **0** (in.) Deposits Extent: **Light**

Infiltration: **None** Pipe Seal Cond: **Cracked**

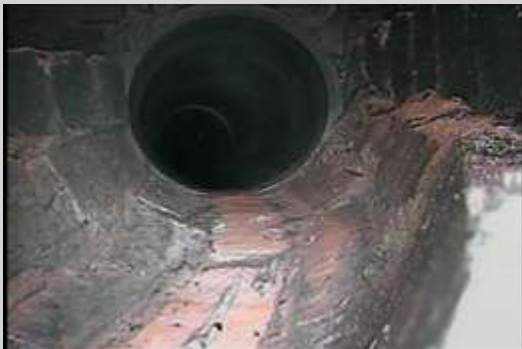
8 in. Circular Gravity Sewer Pipe In @ 3 O'Clock

Infiltration: **Evidence** Pipe Seal Cond: **Cracked**

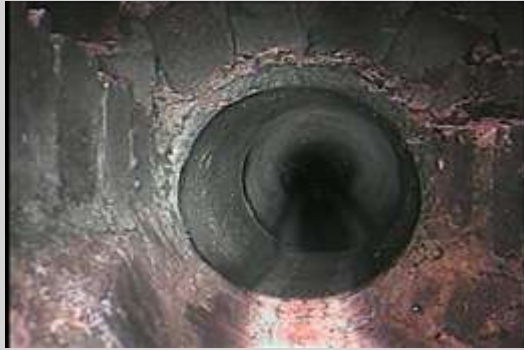
Pipe In @ 9 O'Clock

Deposits: ☐ None ☐ Mud ☐ Sludge ☐ Debris ☒ **Grease**

Infiltration: **Evidence**

Pipe Seal Cond: **Cracked**
